Manhole Inspection Summary

Manhole # S51C__002MH

Insp Date: **5/1/08 9:11 AM**

Location Address: **101 n kenwood ave**

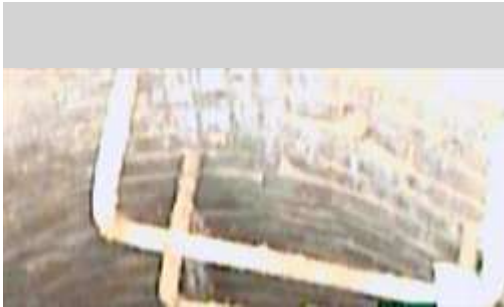
Defect 2

☒ **Evidence Of Surcharge** Depth: **4** (ft.) ☐ Active Surcharge Present

evidence of surcharge

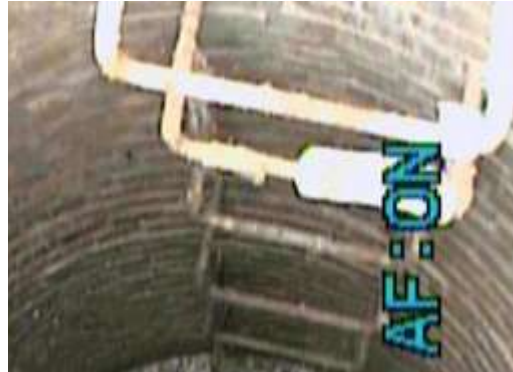
Defect 1

Count: **7** Missing: **0** ☒ **Corroded**

corroded steps, evidence of surcharge on step

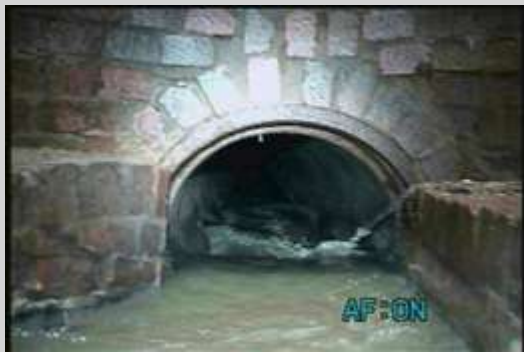
12 O'Clock Outflow

18 in. Circular Gravity Sewer
Pipe Out @ 12 O'Clock

Deposits: ☐ None ☐ Mud ☐ Sludge ☒ Debris ☐ Grease

Silt Depth: 4 (in.) Deposits Extent: Medium

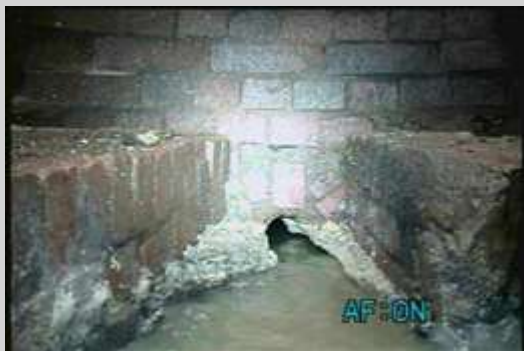
6 O'Clock Inflow

8 in. Circular Gravity Sewer
Pipe In @ 6 O'Clock

Deposits: ☐ None ☐ Mud ☒ Sludge ☐ Debris ☐ Grease

Silt Depth: 3 (in.) Deposits Extent: Medium

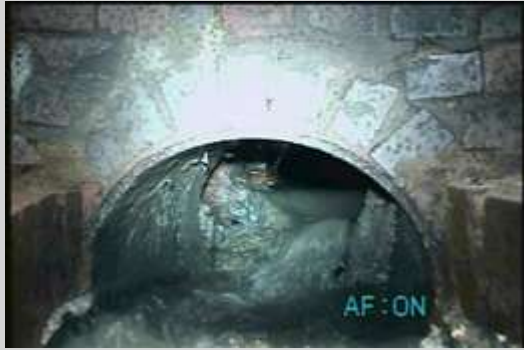
9 O'Clock Inflow

18 in. Circular Gravity Sewer
Pipe In @ 9 O'Clock

Deposits: ☐ None ☐ Mud ☐ Sludge ☒ **Debris** ☐ Grease

Silt Depth: **9** (in.) Deposits Extent: **Heavy**
